# ROOF MOISTURE SURVEYS AT PEASE AFB, NEW HAMPSHIRE, AND OFFUTT AFB, NEBRASKA

Lewis E. Link, Jr.

Mobility and Environmental Systems Laboratory  
U. S. Army Engineer Waterways Experiment Station  
P. O. Box 631, Vicksburg, Miss. 39180

January 1977  
Final Report

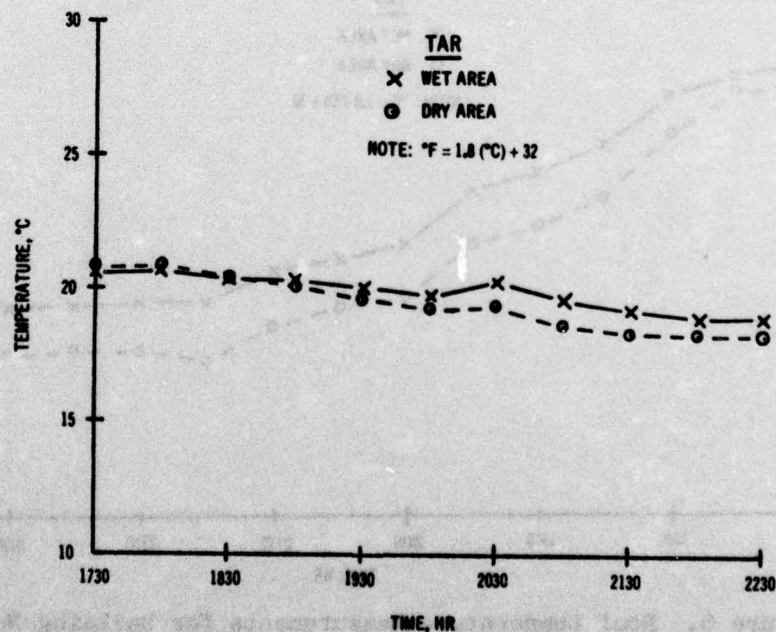
Figure 4. Roof temperature measurements for building No. 112, Pease AFB, New Hampshire

7. Examination of the temperature data in Figures 4 and 6 reveals that a considerable temperature contrast occurred between wet and dry roof areas from approximately 2030 to 2130 hr for building No. 112 and from approximately 1930 to 2330 hr for building No. 130. The time of maximum temperature contrast (considering both buildings) occurred between 1930 and 2130 hr. Examination of Figure 5 reveals that there was very little temperature contrast between the wet and dry roof areas on building No. 119. The lack of contrast was hypothesized to be caused by the persistently cloudy, hazy weather conditions that occurred on the day of measurement, and is a good example of the influence of the weather on the magnitude of the wet-dry temperature contrast and, thus, the potential influence of the weather on the successful delineation of wet and dry roof areas on thermal IR imagery.

8. Based on the temperature data in Figures 4 and 6, the time-of-day for the thermal IR imagery mission at Pease AFB was selected to be approximately 2200 hr.

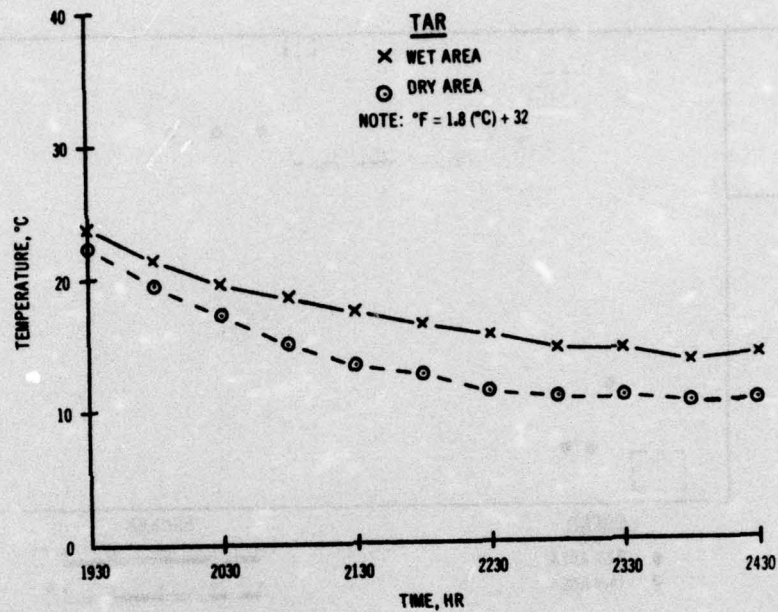
Figure 9. Roof temperature measurements for building No. 407, Offutt AFB, Nebraska

12. Examination of the temperature data for building No. 407 (Figure 9) reveals that a significant temperature contrast between wet and dry roof areas occurred after 2030 hr with a maximum occurring

between 2130 and 2330 hr. The temperature data for building No. 324 (Figure 10) did not have as much contrast as the data in Figure 9, but good control separation occurred from 2130 to 2330 hr as in Figure 9. Based on these data, the time-of-day for the thermal IR imagery mission at Offutt AFB was selected to be approximately 2130 hr.

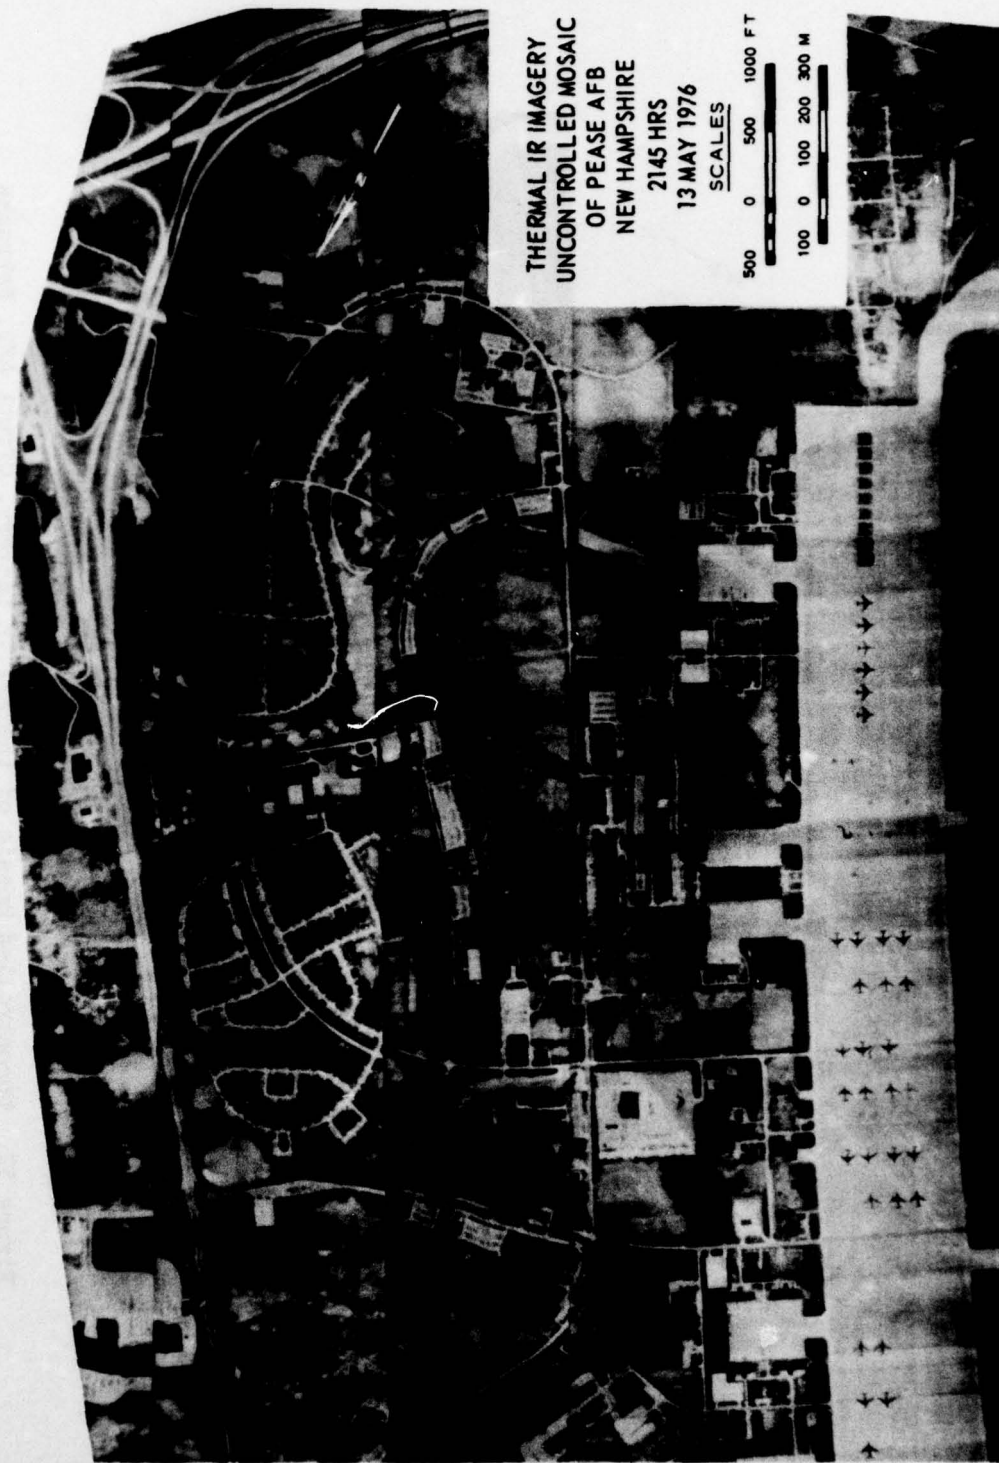
Figure 11. Uncontrolled mosaic of thermal IR imagery, Pease AFB, New Hampshire

22. Examination of the uncontrolled mosaic in Figure 11 shows that the IR imagery for Pease AFB was not of the best quality. The "hazy" appearance of the imagery was caused by fogging of the film (the creation of a significant neutral density on the film by a source other than the planned exposure of the film). The cause of the fogging was not determined, but it may have been due to excess heat near the film or some aspect of the film development process. The fog level on the film was an obstacle for the image interpreter, because it effectively reduced the contrast between the wet and dry roof areas and at times made it difficult to determine the precise outer boundaries of the roofs. The effect of the fogging is especially evident in the imagery enlargements presented for the individual buildings in Figures 13-26.

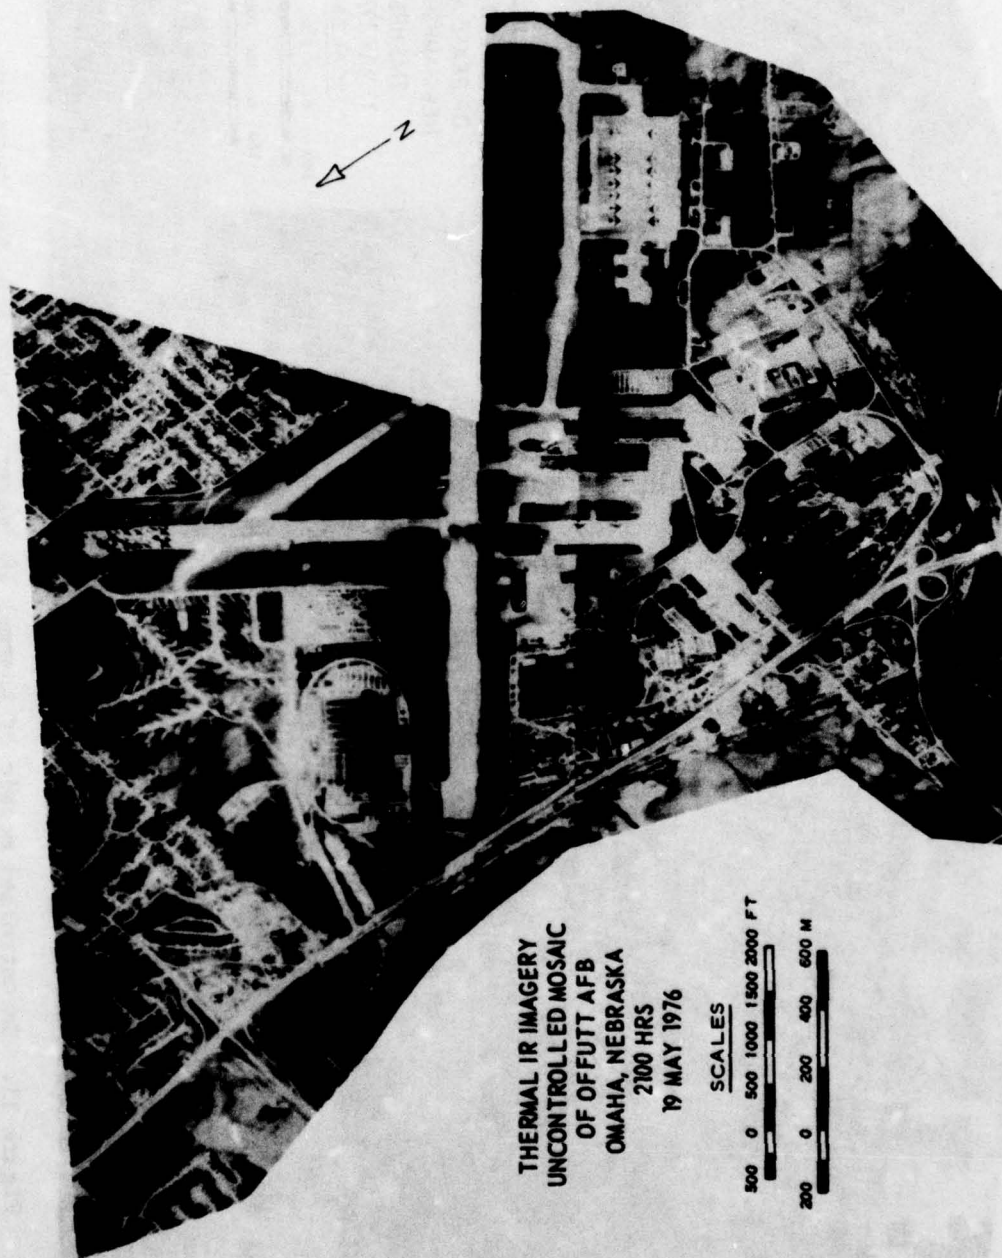
Figure 12. Uncontrolled mosaic of thermal IR imagery, Offutt AFB, Nebraska

26. Examination of the uncontrolled mosaic in Figure 12 shows that the IR imagery for Offutt AFB appeared to be of good quality. The major factor, if any, that may have influenced the quality of the imagery for the purposes at hand was the fact that it was obtained prior to the time specified (at 2100 instead of 2130) to be the optimum based on the roof temperature measurements.

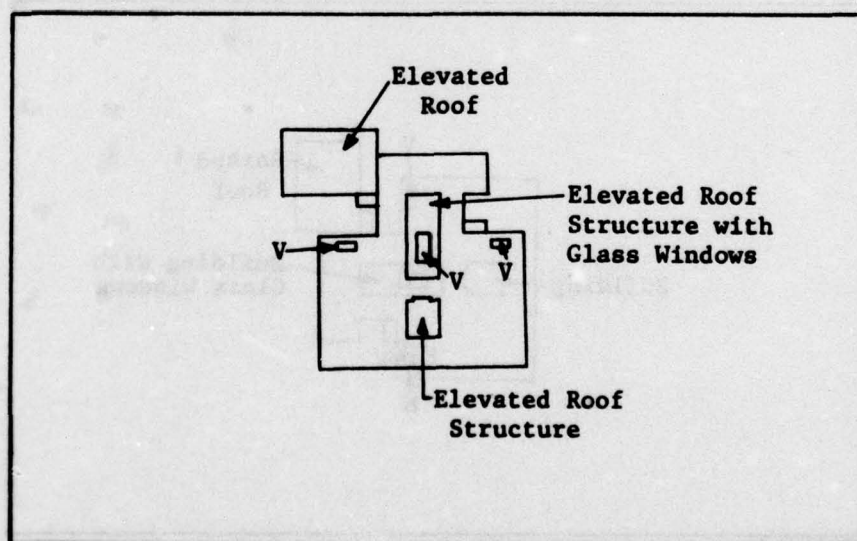
Figure 22. Thermal IR image (a) and identification of anomalies (b) for building No. 46, Pease AFB, New Hampshire

| Building No. | Cause of Warm Anomalies | Remarks |
|---|--|---|
| 46 | Elevated roof structures with vent windows | <u>Figure 22.</u> Same as Figure 21, building No. 85 |

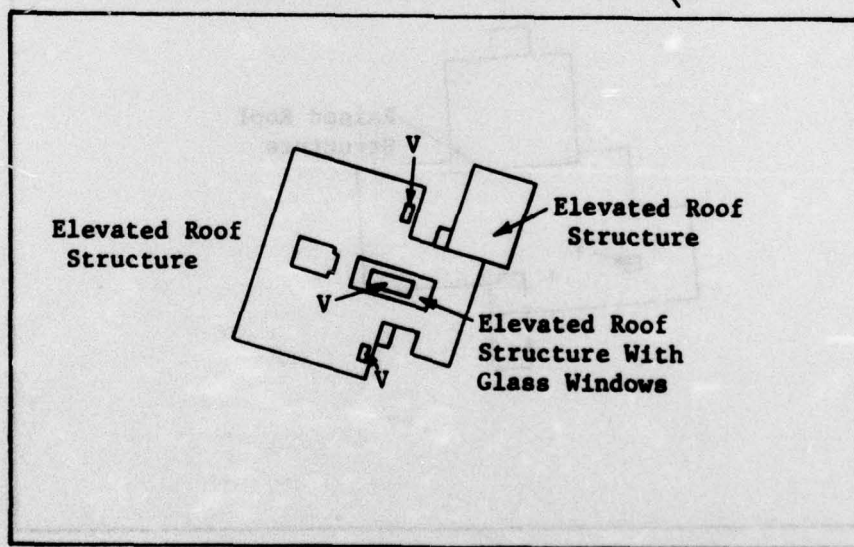
Figure 23. Thermal IR image (a) and identification of anomalies (b) for building No. 6, Pease AFB, New Hampshire

| Building No. | Cause of Warm Anomalies | Remarks |
|---|--|---|
| 6 | Elevated roof structures with vent windows | <u>Figure 23.</u> Same as Figure 21, building No. 85 |
